ACTION MEMORANDUM

SUBJECT: Approval and Funding for a Removal Action at the Red and Bonita Mine Site in San Juan County, Approximately Seven Miles North of Silverton, Colorado.

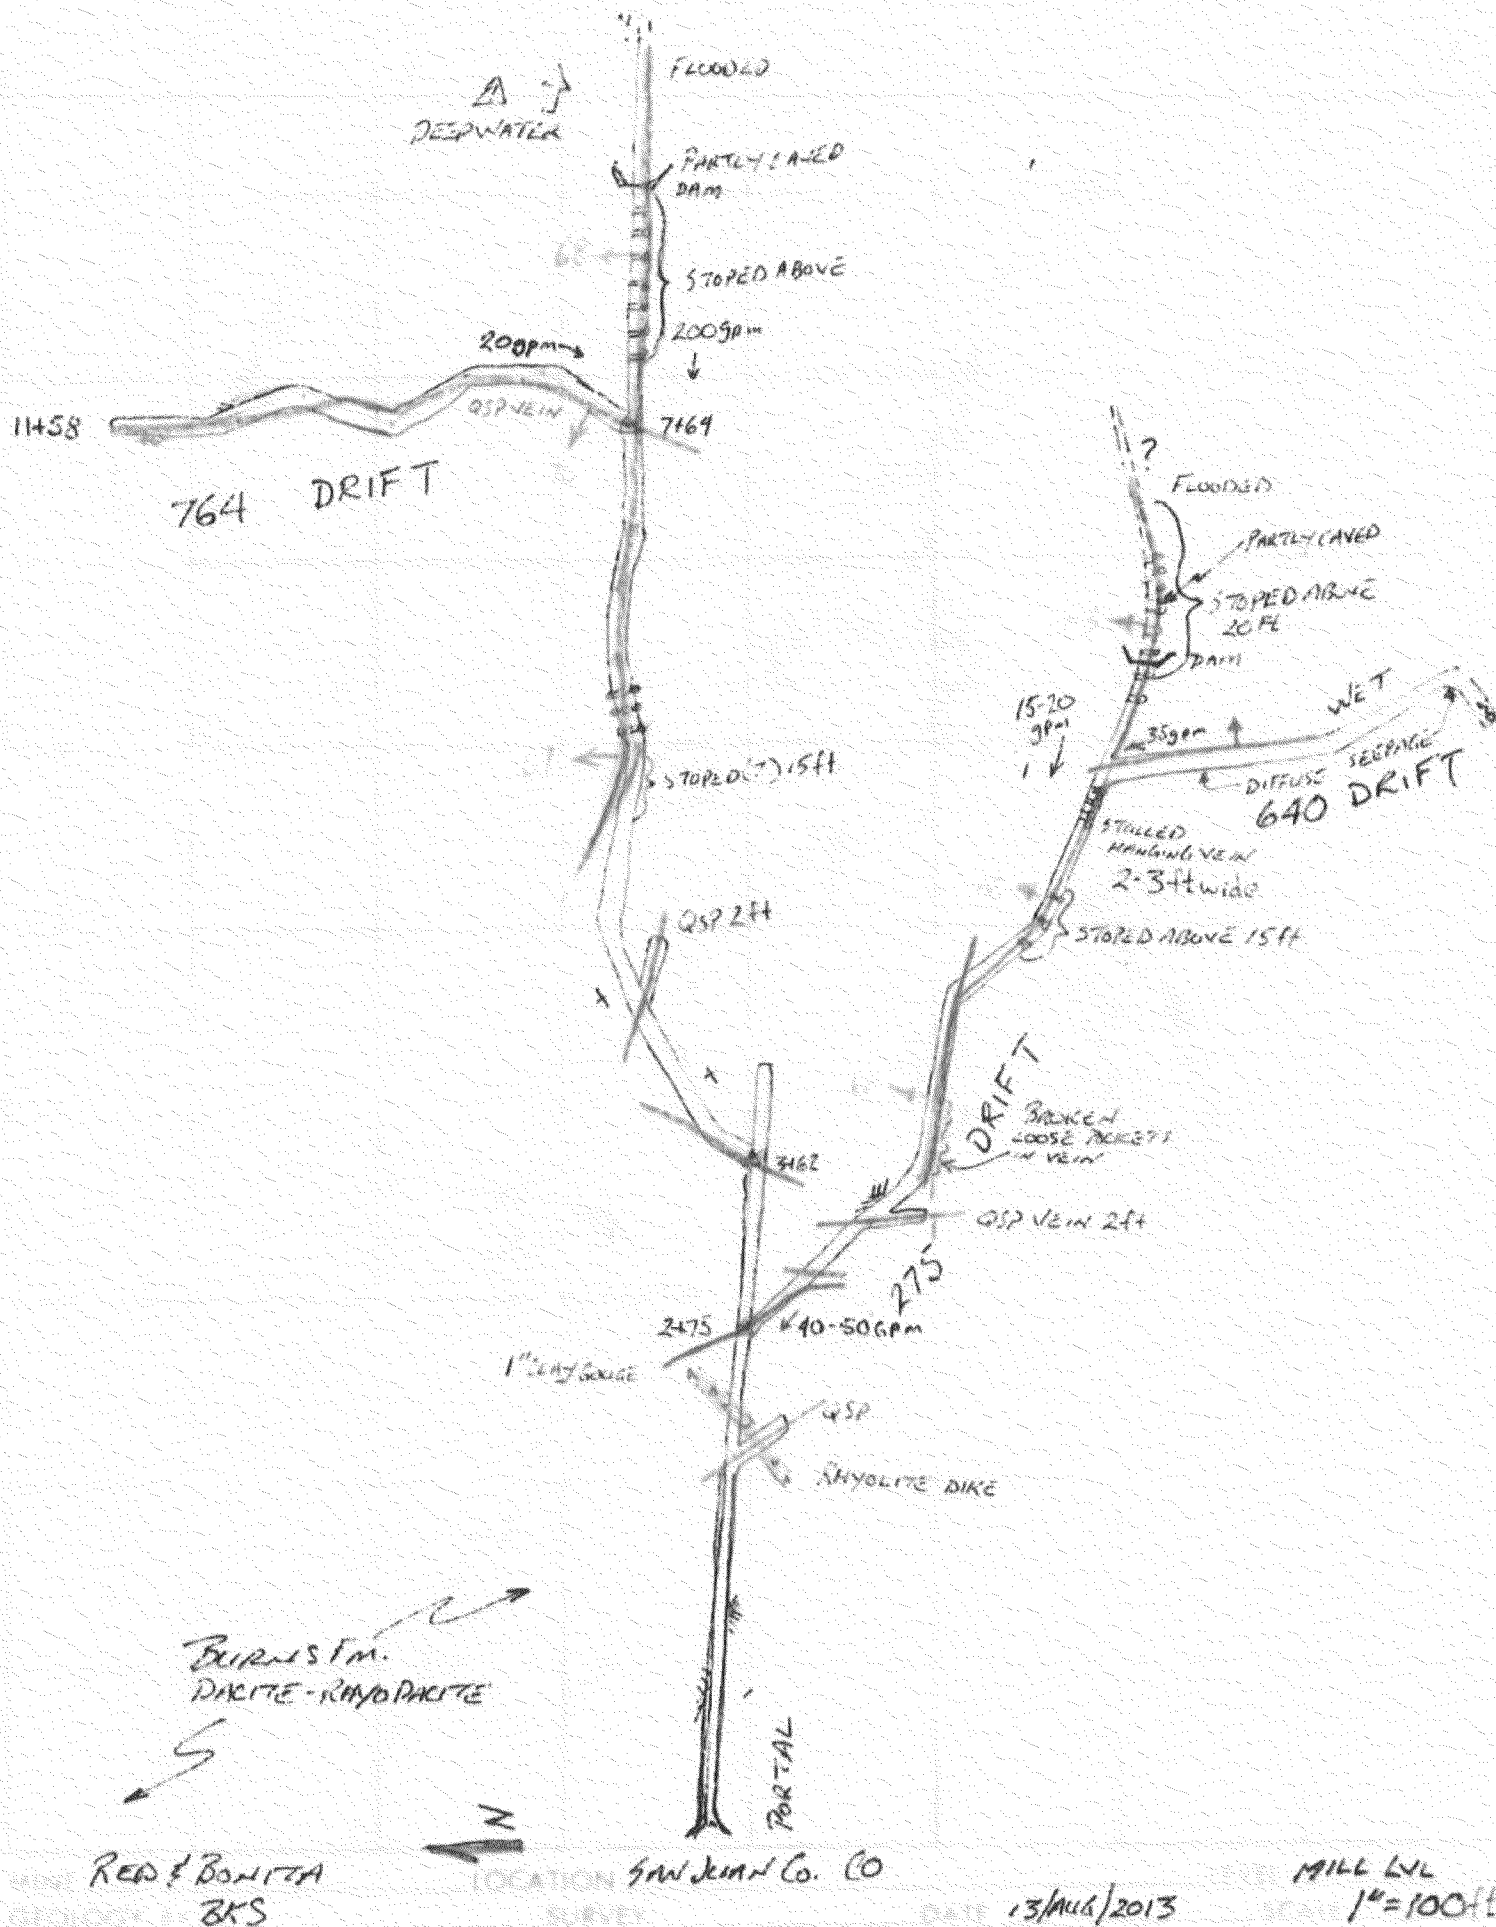
In September/October 2011, the EPA removed blockage in the Red and Bonita Mine opening and constructed a temporary portal for accessing the mine. The mine adit is approximately five feet wide by seven feet high and extends underground for several hundred feet in multiple directions (Attachment 1-Figure 2). Investigations of the mine allowed access to approximately 2,000 feet of workings. Collapsed ground within the tunnels prevented further investigation. However, based on historic

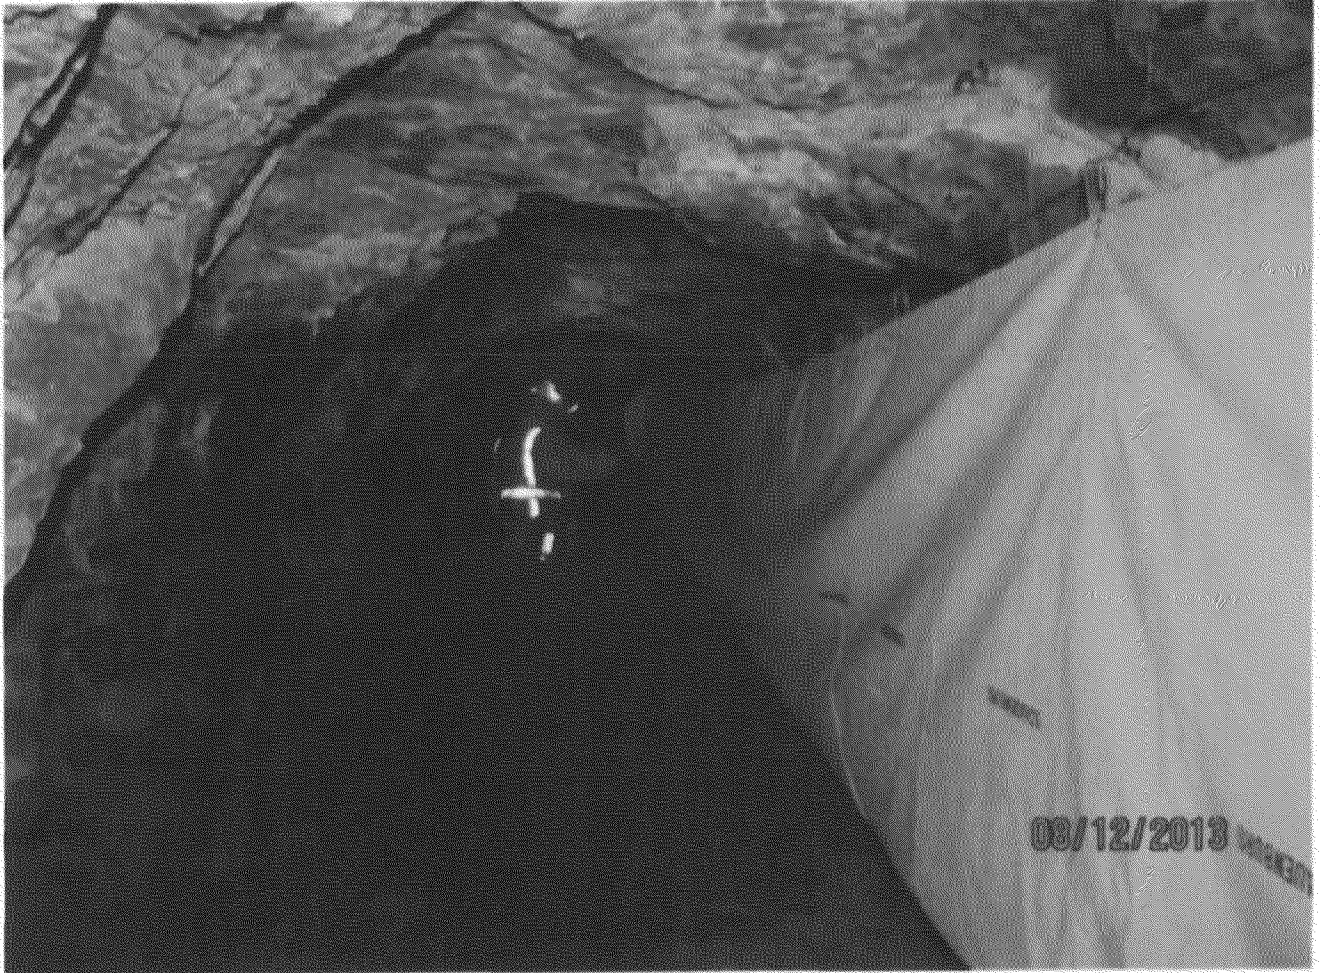
Red and Bonita Mine adit

EPA installed a new portal structure in October 2011 after removing 30 feet of blockage at the adit entrance. Adit discharge flows overland across, and approximately 200 feet down, a mine dump face before being channelized at the toe of the dump. The channel directs flow into an iron bog en route to Cement Creek approximately 500 feet down gradient of the toe of the dump.

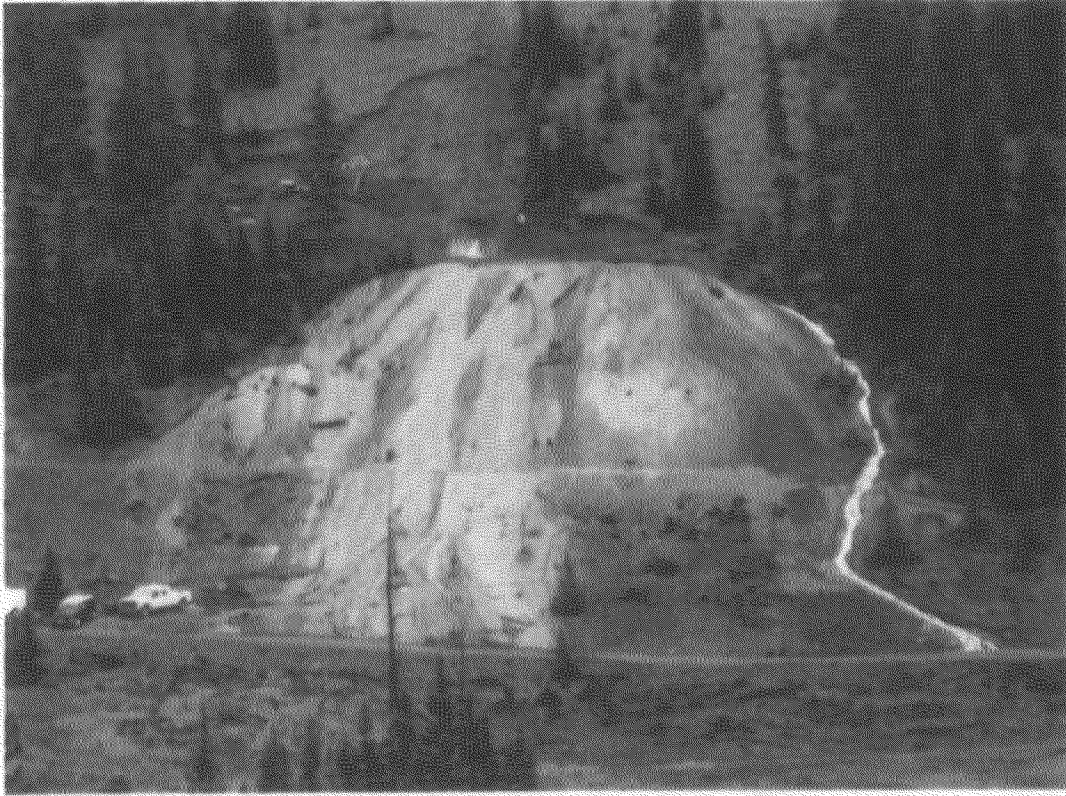
Red and Bonita Mine tailings dump view

The Red and Bonita Mine Site consists of approximately 1.25 acres of waste rock and suspected tailings material and includes an estimated 3,500 feet of underground workings (Stover 2007). The adit, which drains approximately 300 gpm throughout the year with some fluctuations seasonally, discharges to Cement Creek after crossing through a wetland. Prior to the removal assessment work, the mine water discharged through rock debris, as a result of a tunnel collapse that occurred decades ago..

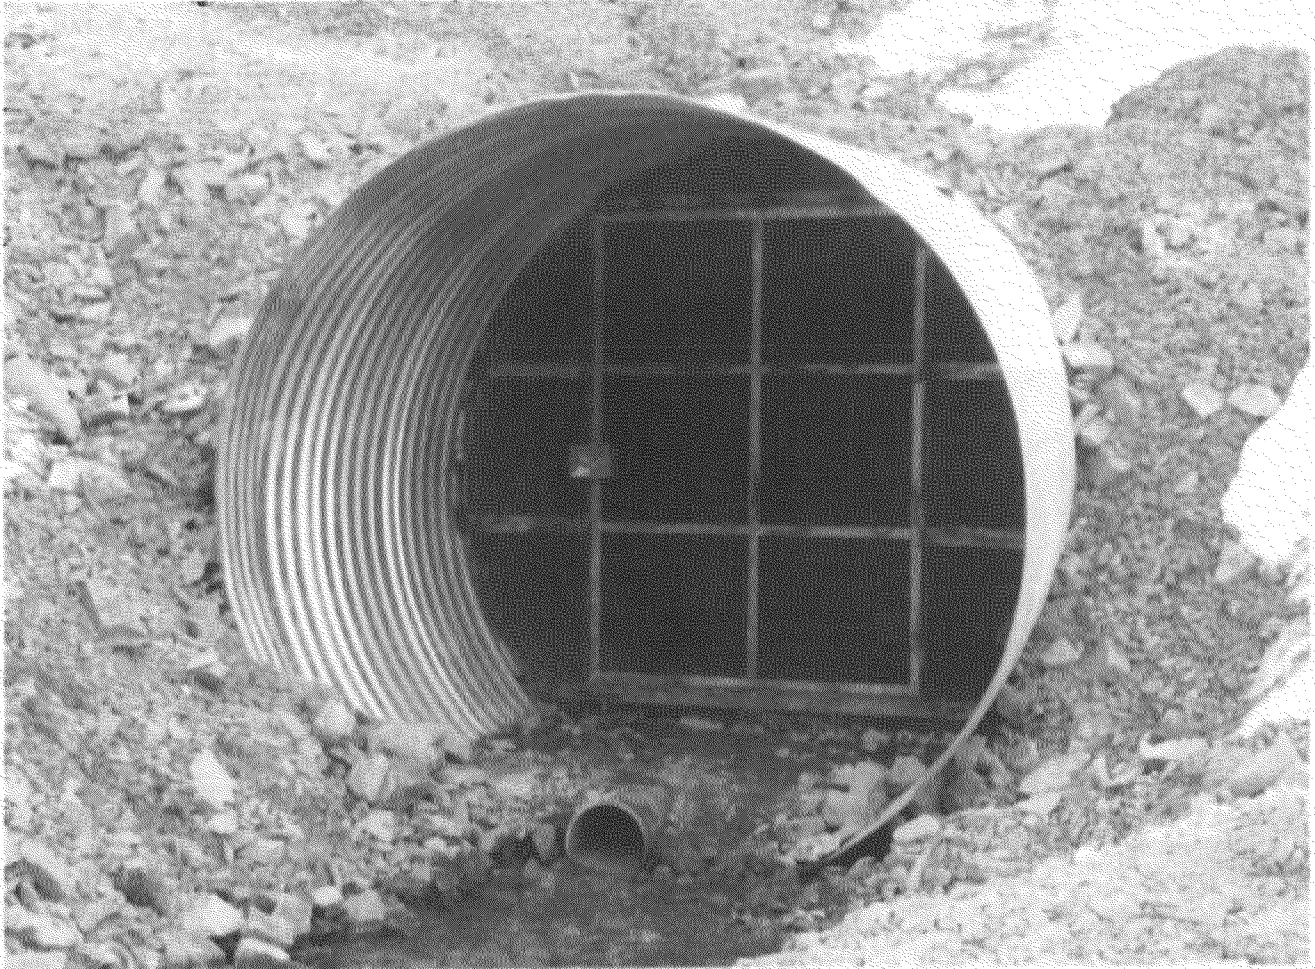
Red and Bonita Mine portal
